Vibration Analysis for Diagnostic Testing of Circuit-Breakers

M. Runde, Member, IEEE
Norwegian Electric Power
Research Institute (EFI)
7034 Trondheim, Norway

Abstract--In order to assess the feasibility of vibration analysis for diagnostic testing of high-voltage circuit-breakers a comprehensive field test program has been carried out. Vibration patterns from 31 breakers (93 identical single-phase units) have been acquired, compared and analyzed. The breakers were assumed to be in good condition with no known irregularities at the time of testing. However, several serious faults, including an incipient rupture of the contact plug shaft, an incorrectly assembled crank, and major lubrication problems were disclosed. Thus, this "blind test" performed under realistic conditions on circuit-breakers in normal service demonstrates that vibration analysis can be a reliable and suitable tool for non-invasive diagnostic testing.

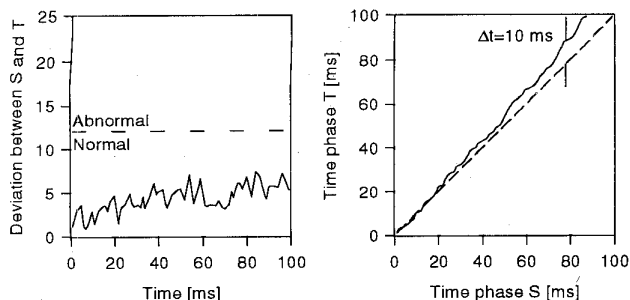
1) *Diagnoses*: Fig. 4 shows the output diagrams from an intercomparison between closing operations of phase S and T of one of the 31 investigated circuit-breakers. The *Deviation vs. time* plot shows that the difference between the vibration signatures is well below 12 units throughout the operation, indicating no notable differences with regard to frequency content and amplitude of the vibration events of these two recordings.

The *Time vs. time* diagram on the other hand shows a clear deviation in timing between the two phases. During the first 20 ms they are synchronous, but from then on phase T gradually

Fig. 4. Comparison between two breaker units of which one (phase T) shows a delay which is assumed to originate in poor lubrication in the driving and transfer mechanism.

lags behind. Towards the end of the closing operation the difference is around 10 ms.

The explanation and origin of these different "delay modes" were proposed by taking into account that in this type of circuit-breaker the contact plug starts moving around 20 ms after the command signal has been given. Deviations in timing that gradually develop from this point, as seen in Fig. 4 (b), signify that the speed of the contact movement is somewhat reduced. The most likely explanation is insufficient lubrication in the mechanical parts responsible for creating and transferring driving force to the moving contact.

Consequently, based on the vibration analyses the owners of the circuit-breakers were recommended to relubricate five driving/transfer mechanisms and four release mechanisms, out of the 93 investigated.

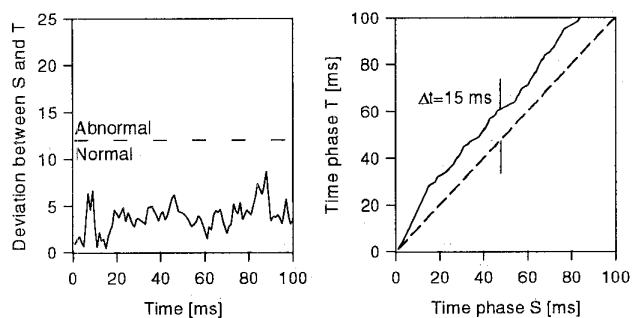
In Fig. 5 diagrams from another circuit-breaker are presented. Also in this case the deviation in frequency content and amplitude is insignificant, whereas the *Time vs. time* plot shows that the operation of phase T is severely delayed ($\Delta t \approx 15$ ms). However, here the deviation in timing occurs within the first 20 ms. For the rest of the closing operation the calculated "path" is parallel to the straight diagonal, indicating no further delays.

Fig. 5. Comparison between two breaker units of which one (phase T) shows a delay which is assumed to originate in poor lubrication in the release mechanism.

Delays of the type shown in Fig. 5 were also assumed to be caused by poorly working lubrication. However, in these cases the delay occurs before the contact movement has started. The only parts active at this time are the relays, shafts, handles etc. that release the main spring, and consequently, the lubrication problems were assumed to be related to the release mechanism.

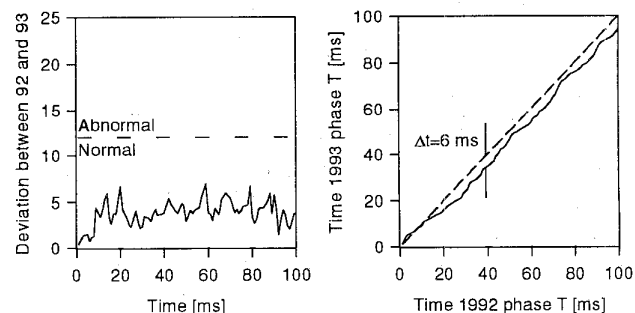
Fig. 6. Comparison between vibration patterns obtained before and after lubrication, indicating that the release mechanism now operates more swiftly.

The *Time vs. time* diagram shows that the release mechanism operates around 6 ms faster in 1993, indicating that the cleaning and relubrication have had a profound effect. The contact travel (i.e., from around 20 ms on) is unaffected, as expected.

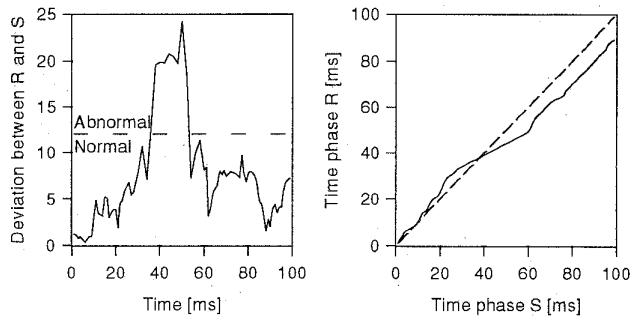
1) *Diagnosis*: Another set of diagrams from the vibration analysis on 31 circuit-breakers is shown in Fig. 7. These diagrams came out by comparing signatures obtained at the operating mechanisms of two phases of a circuit-breaker during closing. Deviations significantly greater than the normal scatter are seen both with regard to amplitude/frequency content (left plot), and timing (right plot).

Fig. 7. Diagrams indicating major discrepancies between phase R and S of a circuit-breaker.

Comparisons between phase R and T, and also between S and T revealed that the deviations observed in Fig. 7 stem from the phase R unit. Both phase S and T show normal vibration patterns.

Also when comparing the signatures from opening operations or from other sensor locations, significant deviations appear. The nature of all the irregularities indicated that the contact travel in some way was irregular, and it was recommended to dismantle the unit and open the arcing chamber for inspection.

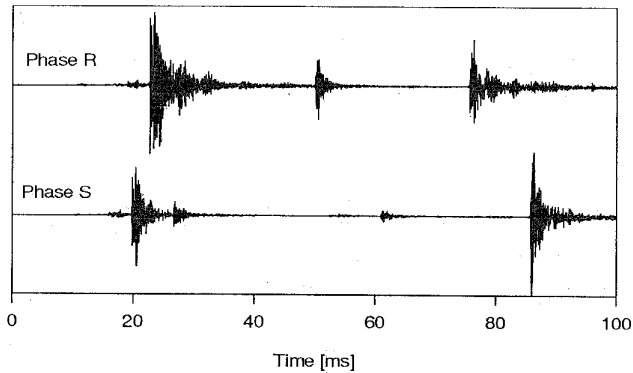
These underlying data are consistent with the *Deviation vs. time* and *Time vs. time* plots. The contact movement of phase R starts a few milliseconds later than in phase S, but is completed as much as 10 ms earlier. (The powerful events starting at around 23 ms / 19 ms and at around 75 ms / 87 ms show when the con-

Fig. 8. Vibration patterns leading to the diagrams in Fig. 7.

tact travel starts and stops, respectively.) Furthermore, the vibration events recorded between 30 and 70 ms are clearly different. (All details of the vibration patterns in this rather quiet period are, however, not visible in Fig. 8.)

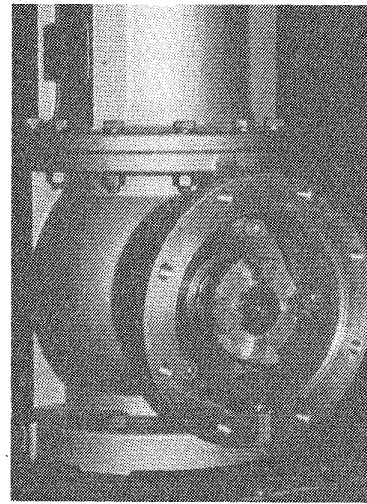
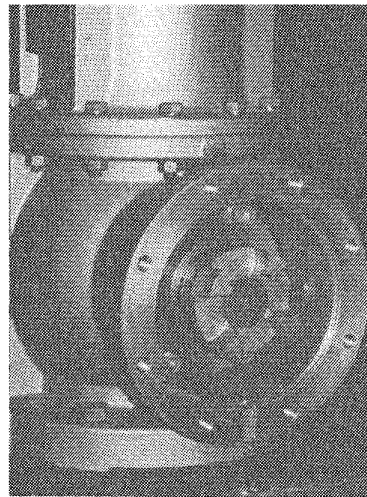
2) *Inspection*: The reason for the deviating vibration patterns was that a four-toothed gear wheel that transfers the mechanical power from the driving mechanism to the moving contact was mounted 30 degrees out of position, see Fig. 9.

Fig. 9. Correctly (a) and incorrectly (b) assembly of the four-toothed gear on the crank shaft. The driving mechanism is to be attached to the flanges and a rotational movement is transferred to the crank with a similar four-toothed gear on the driving mechanism.

When correctly assembled the crank transforms a 180 degrees rotation of the shaft from the driving mechanism to a 20 cm vertical movement during a breaker operation. This brings the moving contact from its uppermost to its lowermost position, or vice versa. This maneuver was to a large extent altered in phase R. The moving contact did neither start nor stop in its vertical end-positions.

Close inspection of the design of the contacts revealed that the insulation distance in open position as a result of this was reduced by around 10 %. Probably more important is that the main contacts barely touched each other when the breaker was in closed position. The arcing contact is not designed to carry load currents continuously, so a severe overheating has probably been avoided with minute margins.

Furthermore, the incorrect assembly also affected the contact speed and the gas flow at the critical moments when the arc is extinguished. Hence, the current-breaking capability of this unit was probably significantly reduced.

This circuit-breaker was among those that underwent a complete revision in 1989, and it is believed that the fault was introduced at that time. Considering the fact that it is possible to assemble such a critical part as this four-toothed wheel incorrectly, it is however felt that the design in itself is to blame, at least partly.

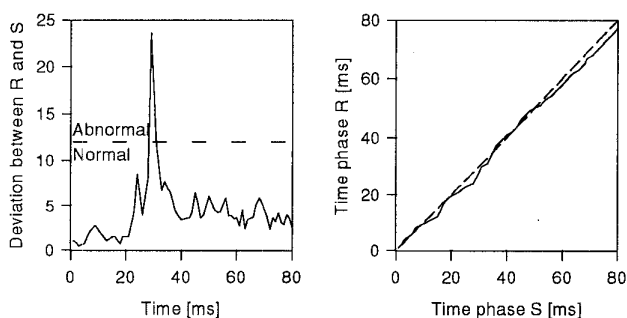
1) *Diagnosis*: Fig. 10 shows diagrams from a comparison between the signatures obtained on two of the arcing chambers of a circuit-breaker. The large deviation occurs at the stage of the opening operation when the arcing contact members are sliding along each other, just before they separate.

Fig. 10. Diagrams from opening operations of phase R and S of a circuit-breaker, indicating major differences in their vibration patterns.

This deviation was assumed to be related to the sliding friction between the arcing contact members. Thus, it was suggested that the arcing contact members in phase S were of a somewhat different material or dimensions than in the rest of the population. This circuit-breaker was completely dismantled during the revision in 1979, and a possible explanation put forward was that the arcing contact members of phase S at that time had been replaced with new ones made of a slightly different material or simply from a different production batch. It turned out, however, that the arcing contacts were not mentioned at all in the revision report. Consequently, it was recommended to open the arcing chamber for inspection.

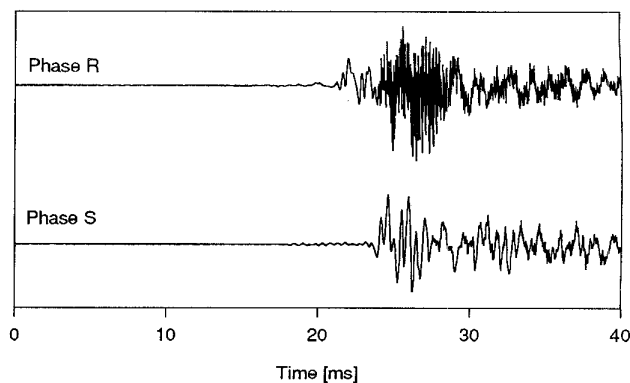
A closer examination of the vibration patterns, see Fig. 11, and also comparisons with recordings from other breakers clarify the character of the deviation. The event in the phase S signature starting at around 23 ms is highly unusual in that it consists primarily of frequencies below a few kilohertz. In all the other 92 units investigated, the sliding of the arcing contact members caused vibrations in the 10 - 30 kHz range.

Fig. 11. The first 40 ms of the vibration patterns from which the diagrams in Fig. 10 are produced.

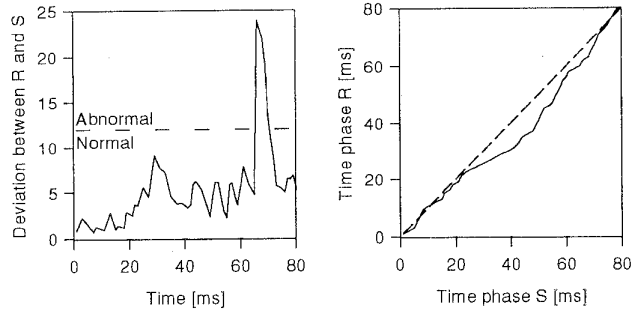
1) *Diagnosis*: The vibration pattern from the arcing chamber of one of the 93 circuit-breaker units contained a very powerful additional event towards the end of the closing operation. Fig. 12 displays how this came out in the vibration analysis, while Fig. 13 shows the related signatures.

Close examination of Figs. 12 and 13 also reveals some additional, but less evident discrepancies after around 30 ms. The calculated deviation is approximately 9 units, and the path in the *Time vs. time* diagram is brought off the diagonal. From about 45 to 60 ms the arcing chamber signatures contain no new,

Fig. 12. Comparison between recordings of two units of which one (phase R) contains a powerful extra event. The input data are shown in Fig. 13.

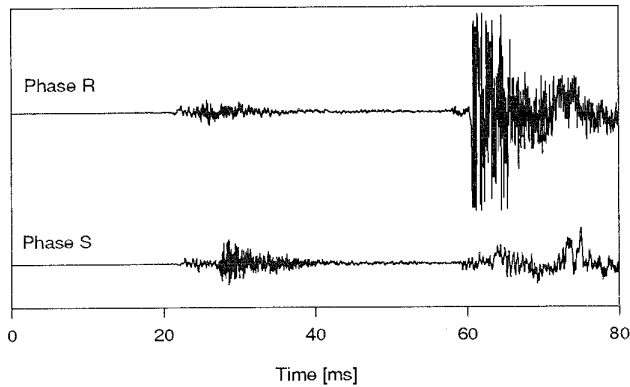
Fig. 13. Normal (phase S) and irregular (phase R) vibration signatures from the arcing chambers during opening operations.

Based on analyses of the vibrations shown in Fig. 13 and also of patterns obtained from the other sensors, it was suggested that the moving contact towards the end of an opening operation hit something it was not supposed to hit, or that some parts of it had loosened. It was recommended to dismantle the breaker for inspection.

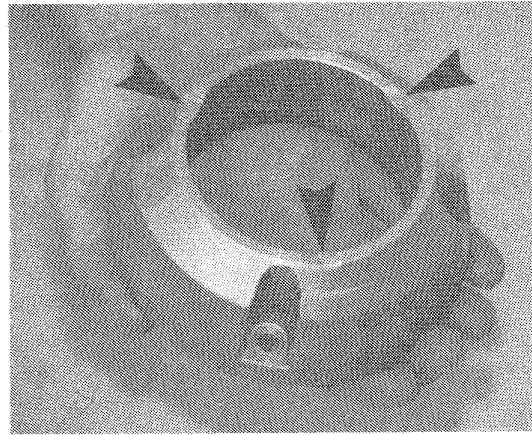
2) *Inspection*: The reason for the irregular vibration signature was that the contact plug was adjusted 6 - 7 mm too low. Due to this, the main contact members did not penetrate as intended in the closed position, and the contact plug went too far down in open position. The latter caused it to hit a guiding ring close to the fixed puffer piston. The hit was very powerful, causing major indents, see Fig. 14, as well as the additional event in the vibration signature in Fig. 13.

In 1987 an instrument transformer nearby exploded and damaged this circuit-breaker. It is believed that the misadjustment stems from the major repair that followed this incident.

Fig. 14. Guiding ring with indents from the incorrectly adjusted moving contact.

3) *New Measurements*: New vibration patterns were recorded after the parts shown in Figs. 14 and 15 had been replaced and the moving contact had been adjusted correctly. As shown in Fig. 16, the repair affected the vibration patterns to a large extent.

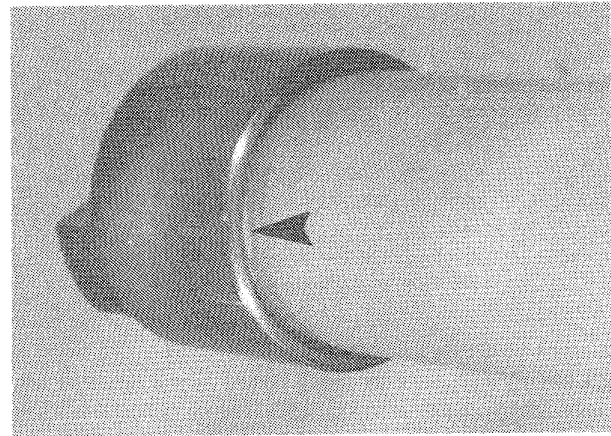
Furthermore, the epoxy shaft on which the moving contact is mounted, was also damaged. As shown in Fig. 15, the epoxy was cracking underneath the metallic parts at the end of the shaft.

Fig. 15. End of the contact plug epoxy shaft with cracks around its circumference.

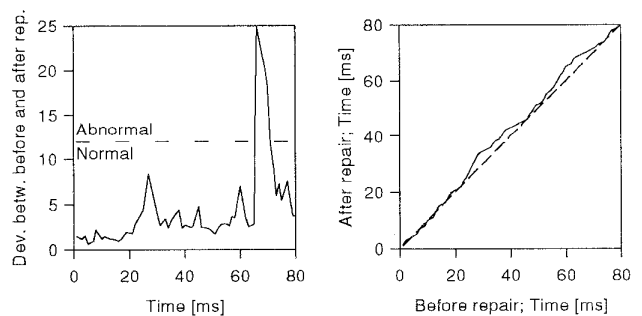
Fig. 16. Comparison between signatures obtained before and after repair, showing major changes.
